Manhole Inspection Summary

Manhole # S69M__009MH

Insp Date: 1/31/08 10:53 AM

Location Address: **6517 O'Donnell St.**

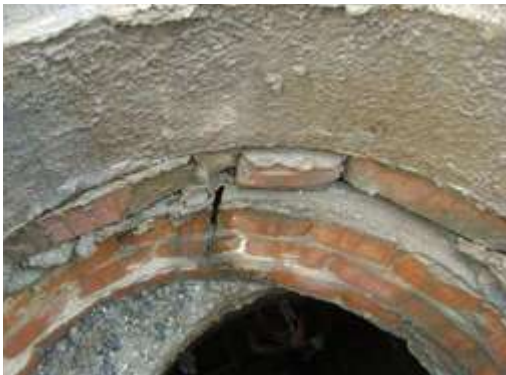
Defect 1

Condition: ☐ Sound ☒ **Cracked** ☐ Root Intrusion ☒ **Loose Brick** ☒ **Deteriorated**

Infiltration: ☐ None ☒ **Joint** ☒ **Cracks** ☒ **Mortar** ☐ Roots ☐ Wall

Loose/cracked bricks in chimney

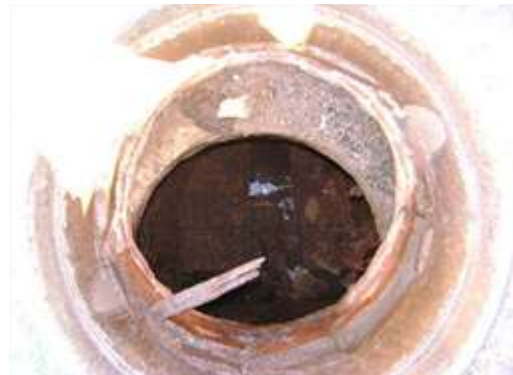
Defect 3

Offset: **6** (in.)

6 in. frame offset

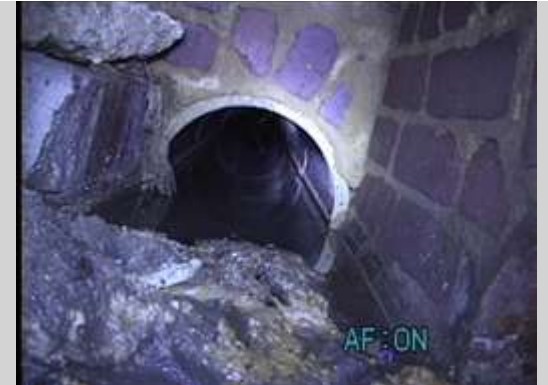
12 O'Clock Outflow

12 in. Circular Gravity Sewer
Pipe Out @ 12 O'Clock

Pipe Height: **12** (in.) Rod and Bar (Angled)
Pipe Material: **Clay** ☐ Pipe Lined
Invert Depth: **10.63** (ft.) Flow Characteristics: **None**
Deposits: ☐ None ☐ Mud ☒ ~~Sludge~~ **Debris** ☐ Grease
Silt Depth: **4** (in.) Deposits Extent: **Heavy**
Infiltration: **None** Pipe Seal Cond: **Sound**

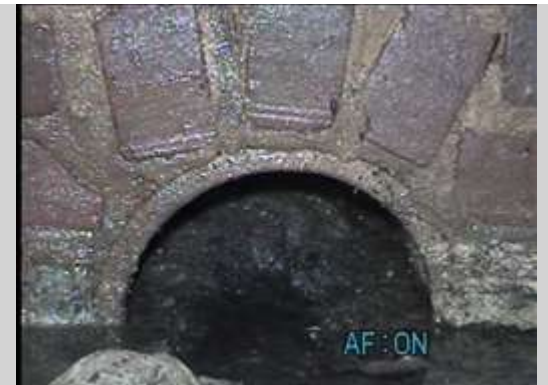
3 O'Clock Outflow

Comments **FIELD CREWS VERIFIED THAT S69M__009MH DOES NOT CONNECT TO S69M__028MH. THE 3 O'CLOCK PIPE ON S69M__009MH IS ABANDONED AND DOES NOT CONNECT AS THE MAP INDICATES. HEAVY DEBRIS IN CHANNEL OF INCOMING 9 O'CLOCK.**

8 in. Circular Gravity Sewer
Pipe In @ 3 O'Clock

Pipe Height: **8.4** (in.) Rod and Bar (Angled)
Pipe Material: **Clay** ☐ Pipe Lined
Invert Depth: **10.50** (ft.) Flow Characteristics: **Slow**
Deposits: ☒ None ☐ Mud ☐ ~~Sludge~~ ☐ **Debris** ☐ Grease
Silt Depth: (in.) Deposits Extent:
Infiltration: **None** Pipe Seal Cond: **Sound**

Connects To: **Stub connection / abandoned**

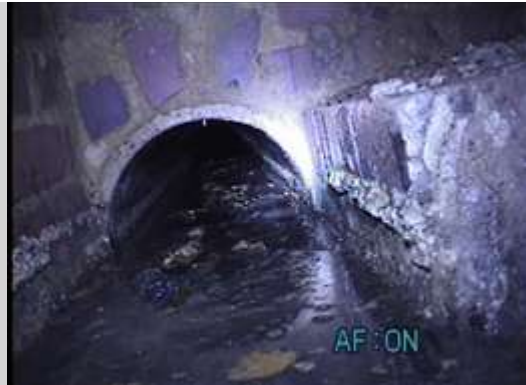
6 O'Clock Inflow

Pipe In @ 6 O'Clock

Deposits: ☐ None ☐ Mud ☒ **Sludge** ☒ **Debris** ☐ Grease

Silt Depth: **10** (in.) Deposits Extent: **Heavy**

Connects To: **Stub connection / abandoned**

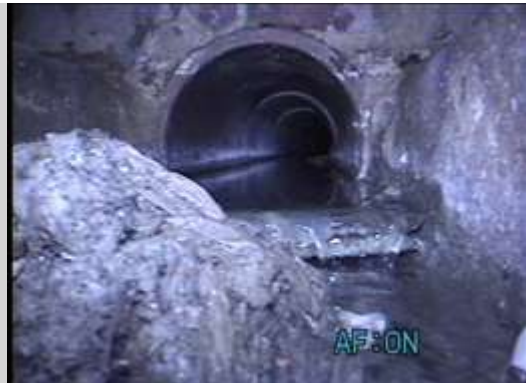
9 O'Clock Inflow

Pipe In @ 9 O'Clock

Deposits: ☐ None ☐ Mud ☒ **Sludge** ☒ **Debris** ☐ Grease

Silt Depth: **8** (in.) Deposits Extent: **Medium**
